JERA Power Taketoyo GK

Fire Accident at Taketoyo Thermal Power Station

Recurrence Prevention Measures

Fire Accident Investigation Committee at Taketoyo Thermal Power Station

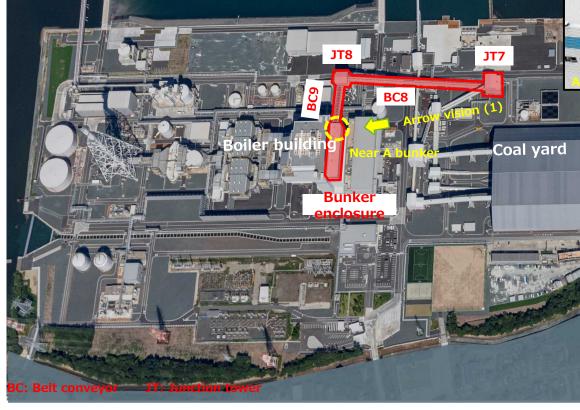
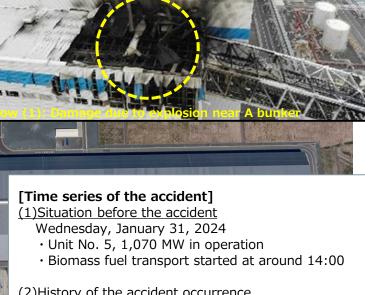
Range of damage to main facilities by fire

\cdot Based on video data, the ignition point is considered to be near A bunker.

- The event is considered to be a dust explosion caused by biomass fuel.
- There was no significant damage to facilities other than the bunker enclosure to JT7.

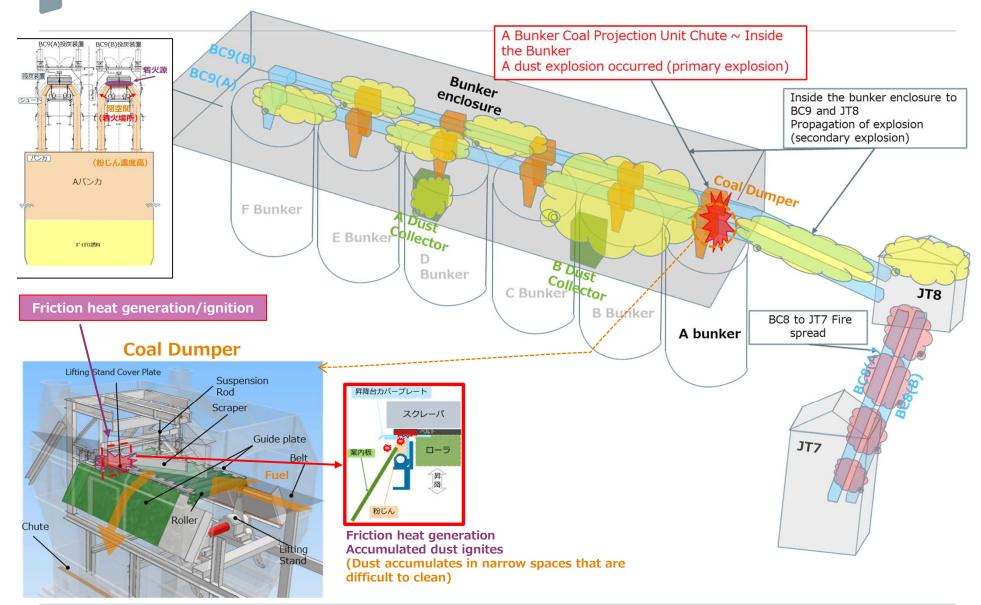
Mechanism of the Accident (Overall)

- This event was caused by the inherent characteristics of biomass fuel (white pellets).
- Due to differences in fuel properties, similar accidents do not occur with coal.

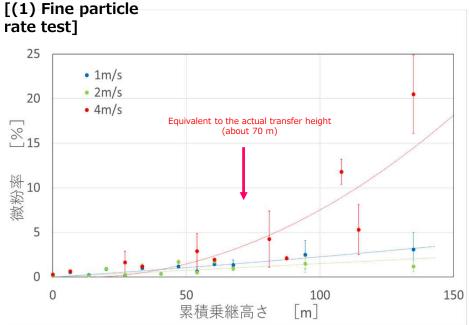
The fine particle rate is almost the same at 1 m/s and 2 m/s, but at 4 m/s, the fine particle rate remarkably increases due to the collision of fuel with the chute at the junction.

• By reducing the conveying speed from 4 m/s to **2 m/s or less, the total amount of dust can be reduced**.

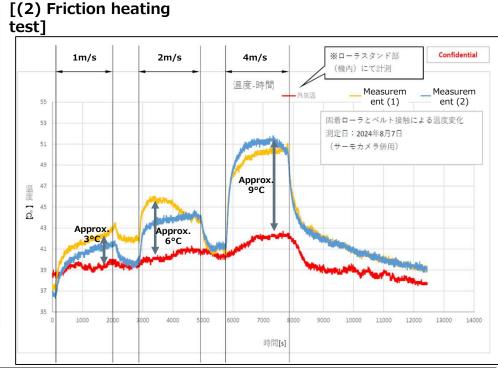
Temperature rise due to friction is almost proportional to the conveying speed
 The temperature reached by frictional heat generation is about 40~50°C, which is sufficiently lower than the biomass fuel ignition temperature value sufficiently low compared to

It is considered that even under frictional conditions where the coefficient of dynamic friction and load increase and the temperature rises close to the ignition temperature, the **temperature rise can be almost halved by halving the conveying speed**.
