JERA Power Taketoyo GK

Fire Accident at Taketoyo Thermal Power Station

Recurrence Prevention Measures

Fire Accident Investigation Committee at Taketoyo Thermal Power Station

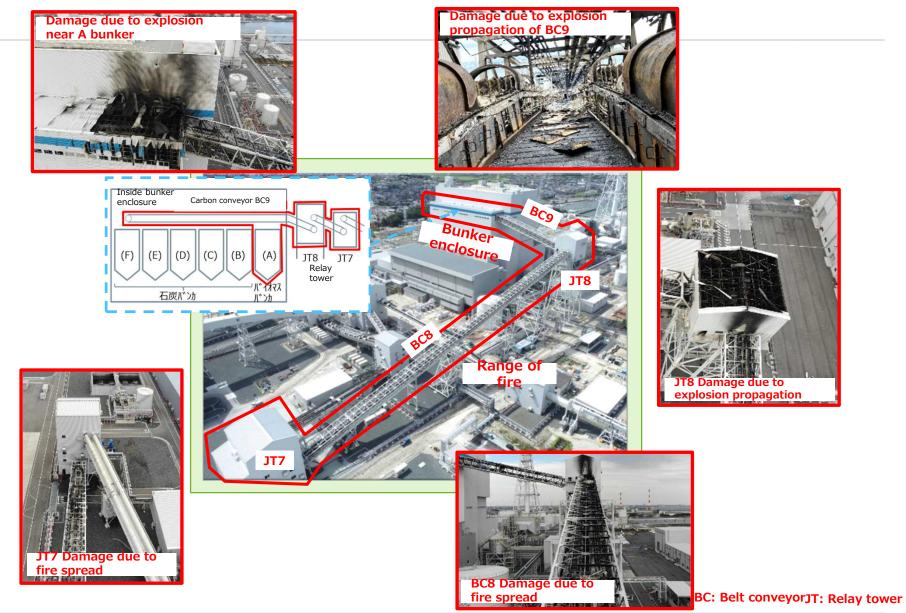
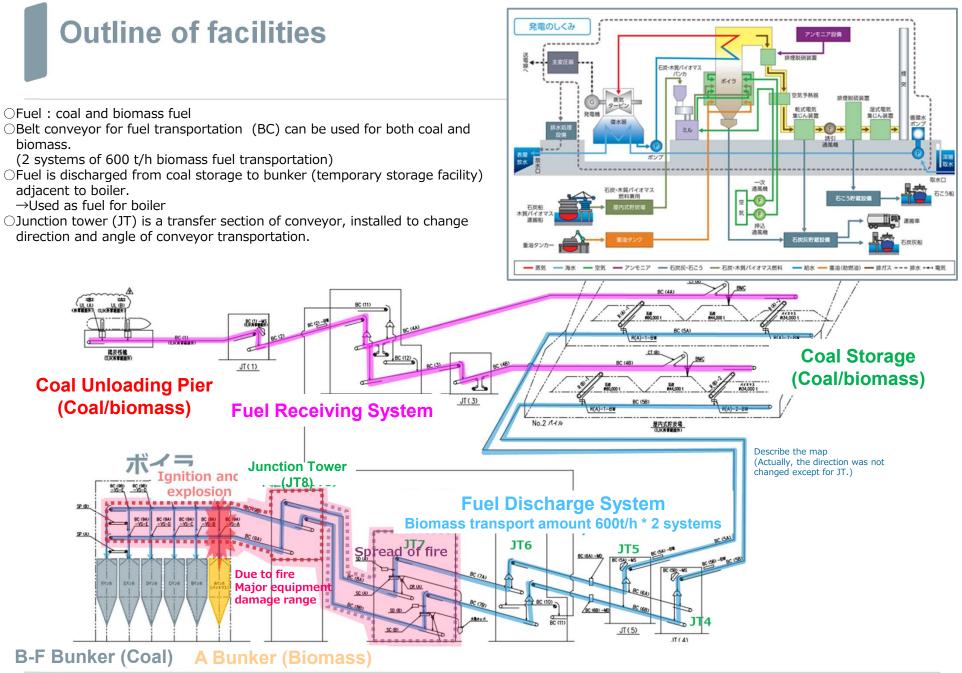
Outline of the accident (2/2)

(2)History of the accident occurrence Wednesday, January 31, 2024
15:11 Explosion sound from boiler, boiler building
13 Black smoke was observed from around FL No personal injury occurred
20:04 Fire was extinguished
Thursday, February 1, 2024
2:40 Fire broke out again near the belt conveyor
3:34 The fire was confirmed to be extinguished.

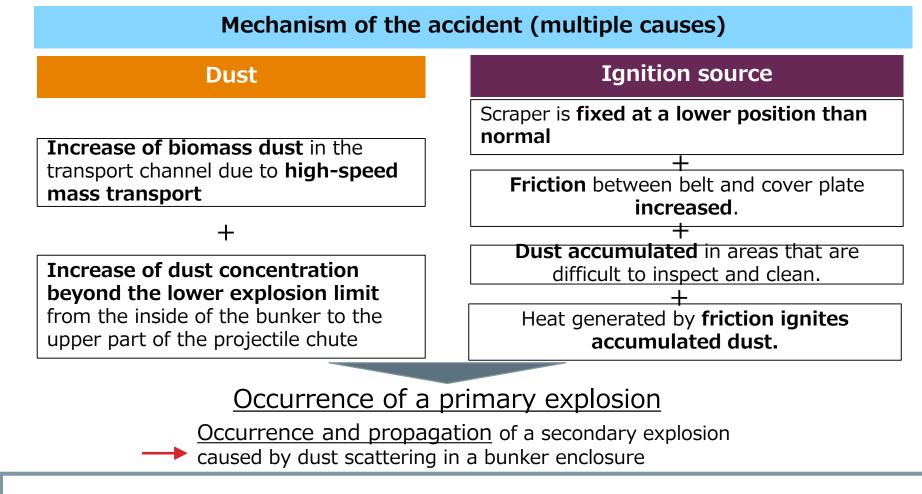
Summary of the results of deliberations by the Accident Investigation Committee up to the 3rd meeting

- This event was caused by the inherent characteristics of biomass fuel (white pellets).
- Due to differences in fuel properties, similar accidents do not occur with coal.

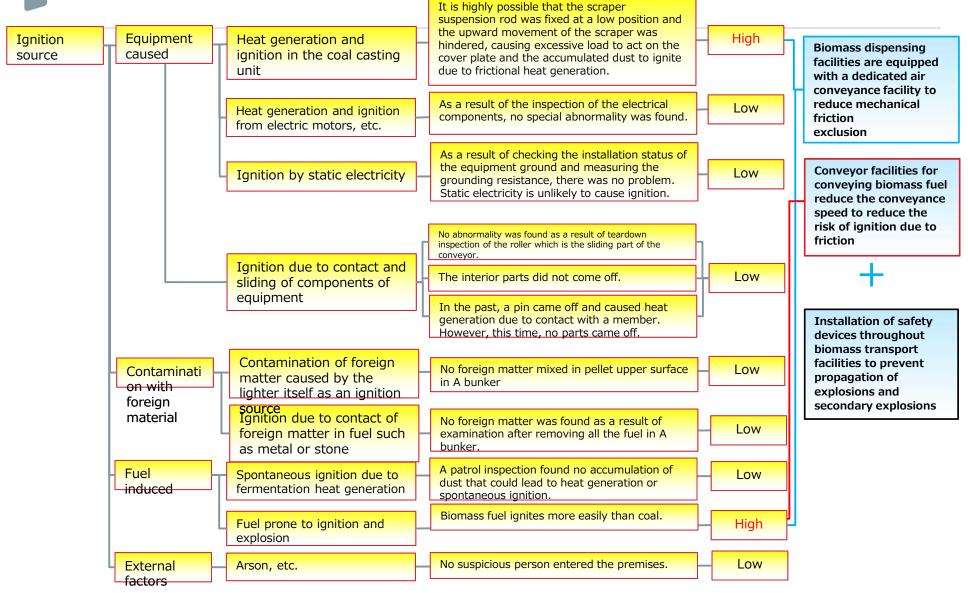
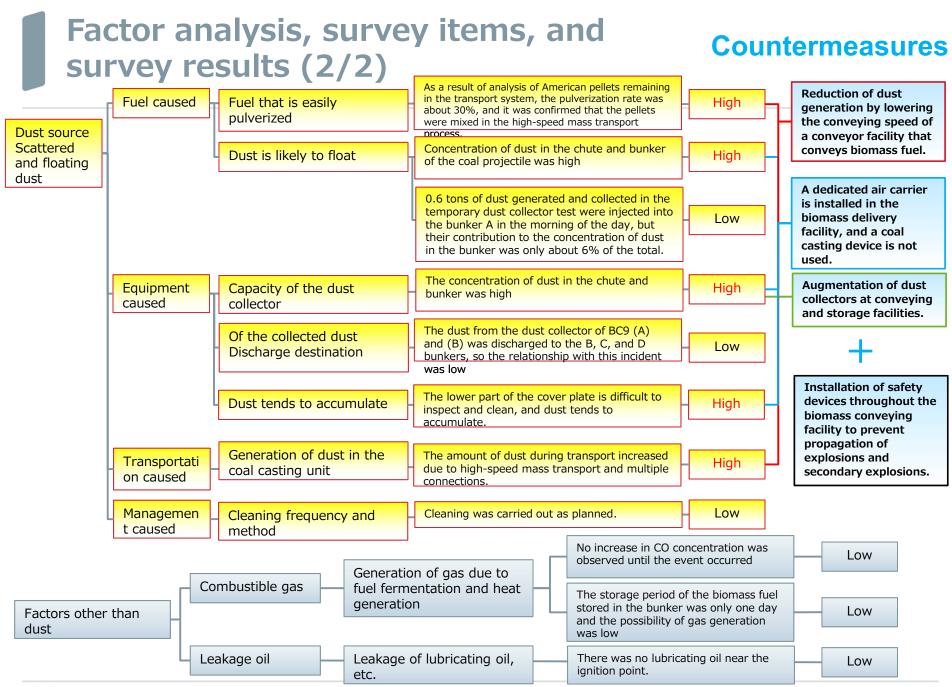
Factor analysis, investigation items, and investigation results (1/2)

Biomass	Coal	Evaluation	
Dust concentration	 White pellets have a large amount of fine particles in the fuel Due to particle size distribution, many small particles tend to scatter The amount of dust increases due to transportation and transit, and the dust concentration in the system is high Lower explosion limit concentration: Small (about 95 g/m 3) Measured values (transit buildings, etc.) Up to 80 g/m3 	 Coal fines are about 1/5 of white pellets In terms of particle size distribution, there are many large particles, and surface moisture makes them difficult to scatter. The dust concentration in the system is the same as that of white pellets. Approx. 1/500 Lower Explosion Limit High (Approx. 230 g/m 3) The measured dust concentration in bunkers and silos during coal transport is extremely low at approximately 2~7 mg/m3. 	Coal has little risk of dust generation and ignition heat generation, and the dust concentration in the

Countermeasures
